ESS Vibration Failure of a COTS Power Supply

Aaron C. Dermarderosian
Senior Principal General Engineer
Misson Systems Services

May 1st, 2024

Failure Investigation- COTS AC/DC Converter; 5 & 12V DC Output

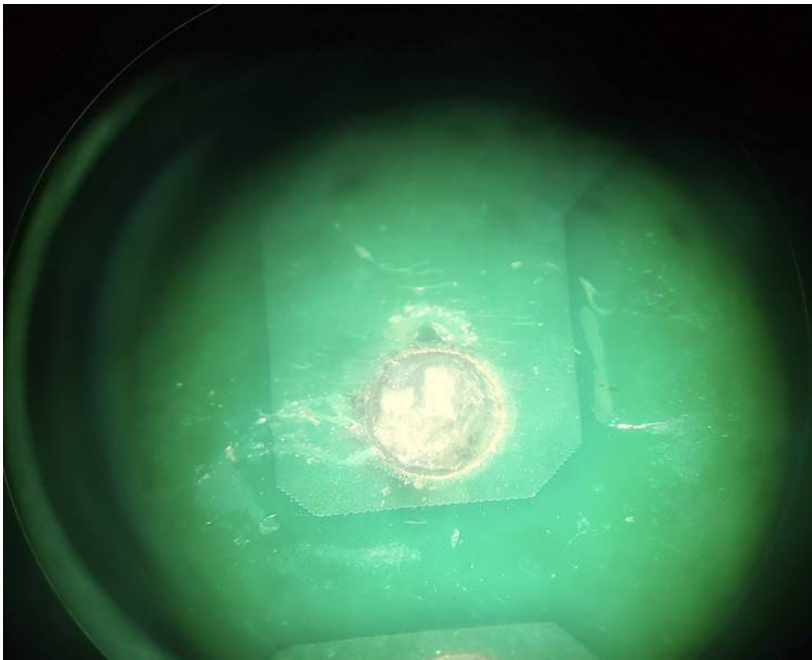
A switchable (120/240V) portable AC/DC power supply failed following transit case vibration qualification tests.

1. Portable supply functionally tested before and after testing.
2. No power output from 5VDC or 12VDC outputs, following qualification test.
3. Initial dis-assembly showed there was a failed solder joint on the AC Line connection to the PCB.

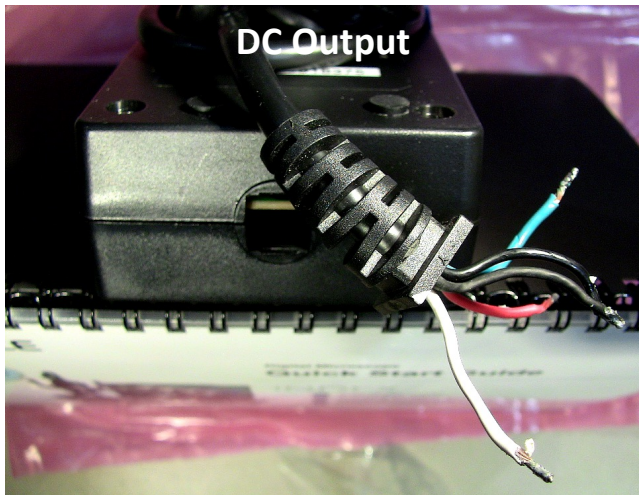
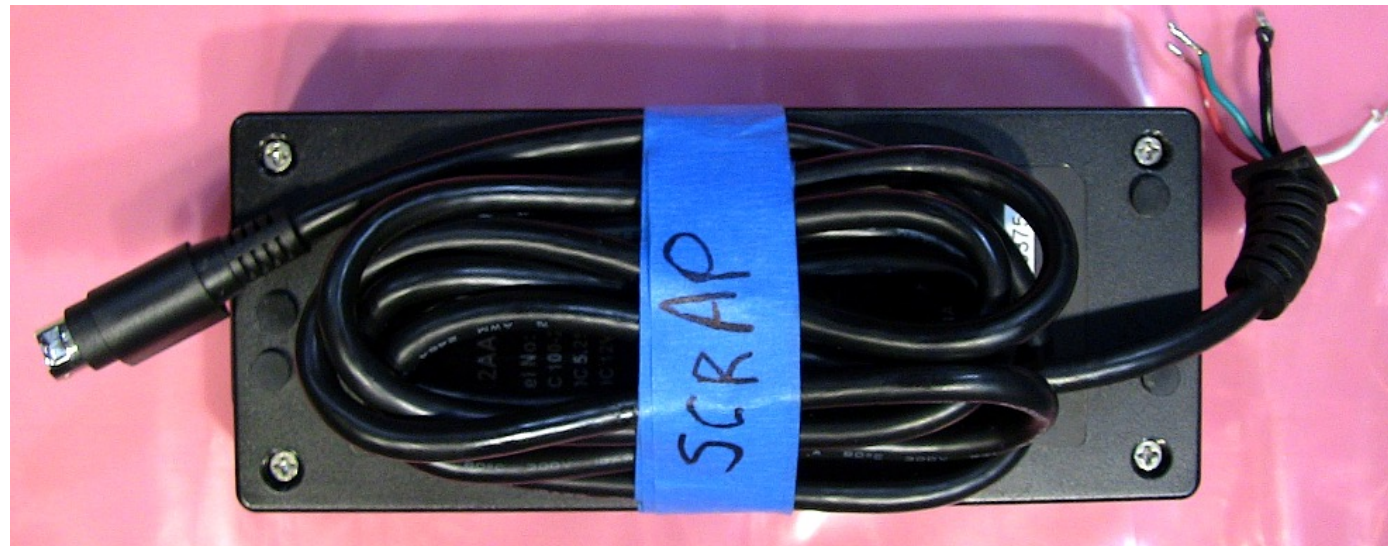
AC/DC Converter as received

Serial Number includes embedded date code. Supply built in 2018, approximately **6 years old**

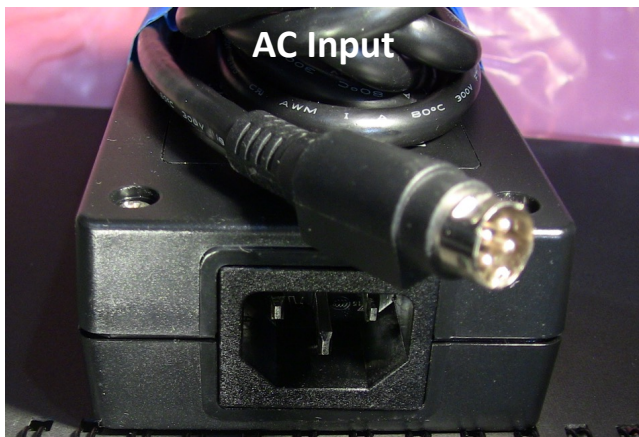
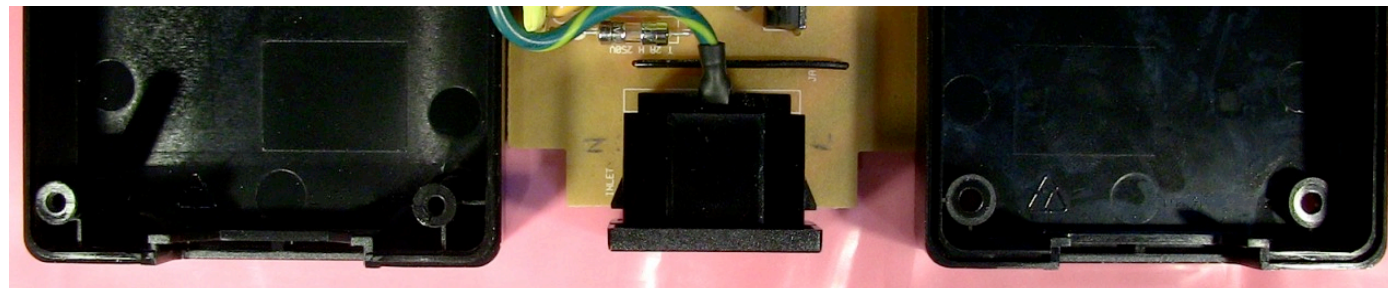
Top / Bottom Shell Opened- Issue noted with IEC-320 AC Socket

Old Test asset had to be used (*prior use history!*)
Legacy program- NO production units available

Power supply partially dis-assembled during initial assessment

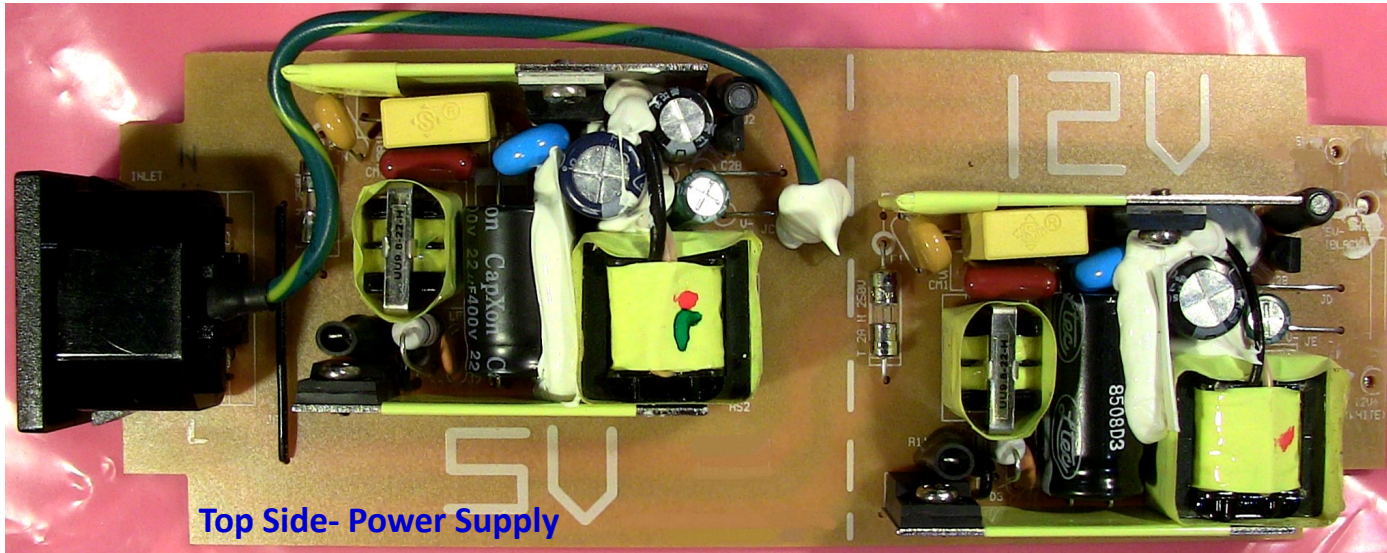
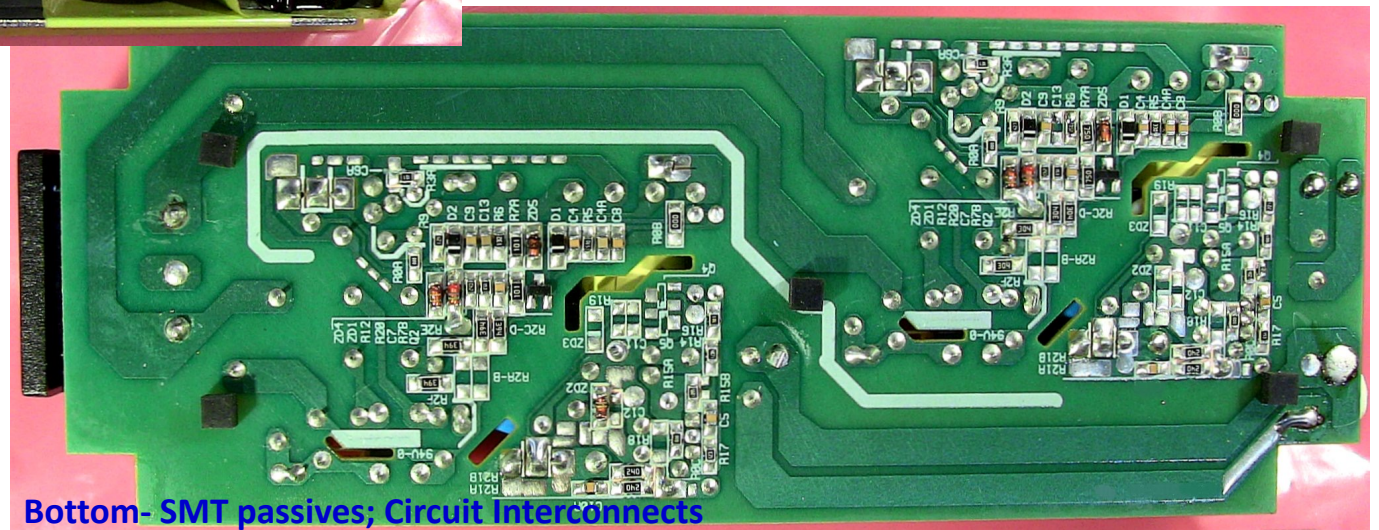
- I. Rugged single layer design, no plated thru-holes
- II. **Top-** power supply thru-hole components
- III. Nickel plated thermal sinks, polyimide tape and RTV used to provide voltage Isolation & Shock/Vibration dampening!
- IV. **Bottom-** Logic & Control SMT, connected to topside via leads and wires, solder mask & coatings used for electrical isolation

Power Pack PCB / Enclosure is ruggedized!

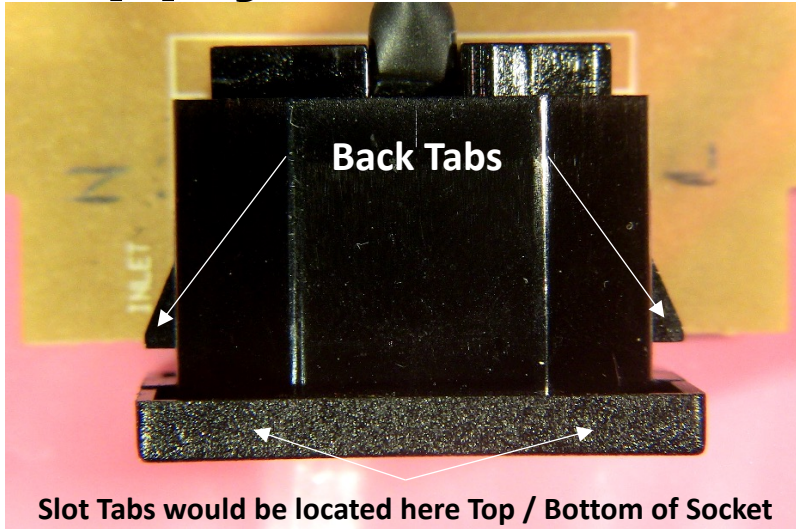
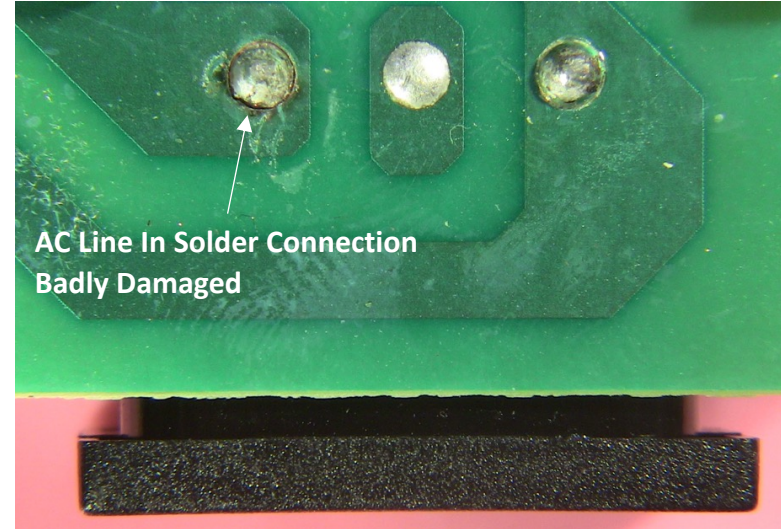
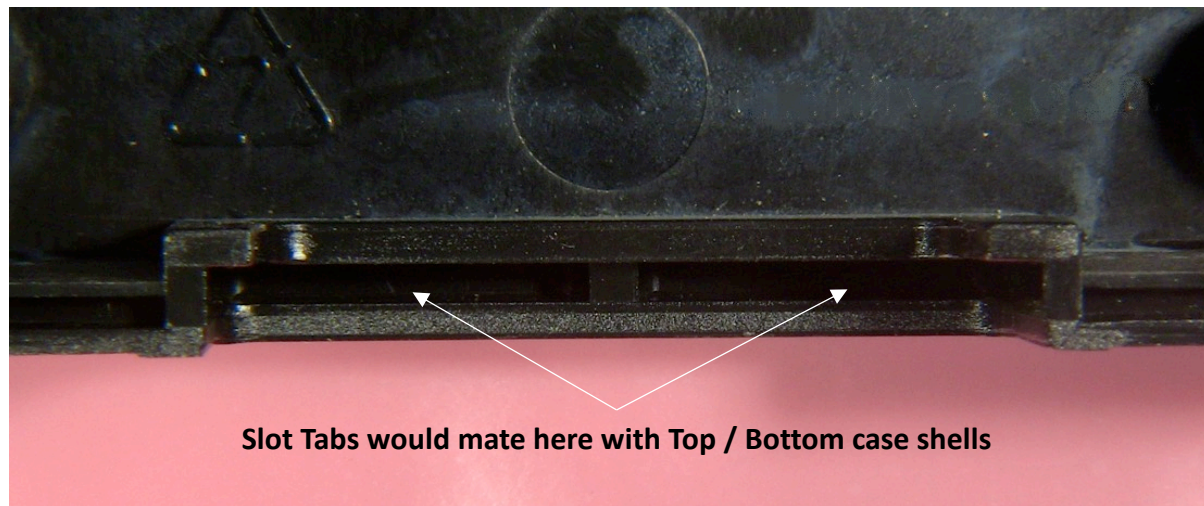
Power Supply- *Back Tab & Slot Tabs, Not Utilized*

Supply Chain Issue: Mis-application of IEC-320 Socket to slot tab enclosure design

8. An alternate (available) IEC-320 socket was integrated that **DOES NOT** contain mating retention tabs. The alternate socket **DOES** contain an inner shell “back tab”, but is designed for a thicker wall dimension. The tab **Does NOT** achieve contact with this feature to restrain the socket during power cord insertion/removal cycles.

10. While The IEC-320 socket applied to this enclosure Provides a mechanical back-stop (insertion force), the back tab is not providing mechanical restraint, when un-plugging the AC Cord.

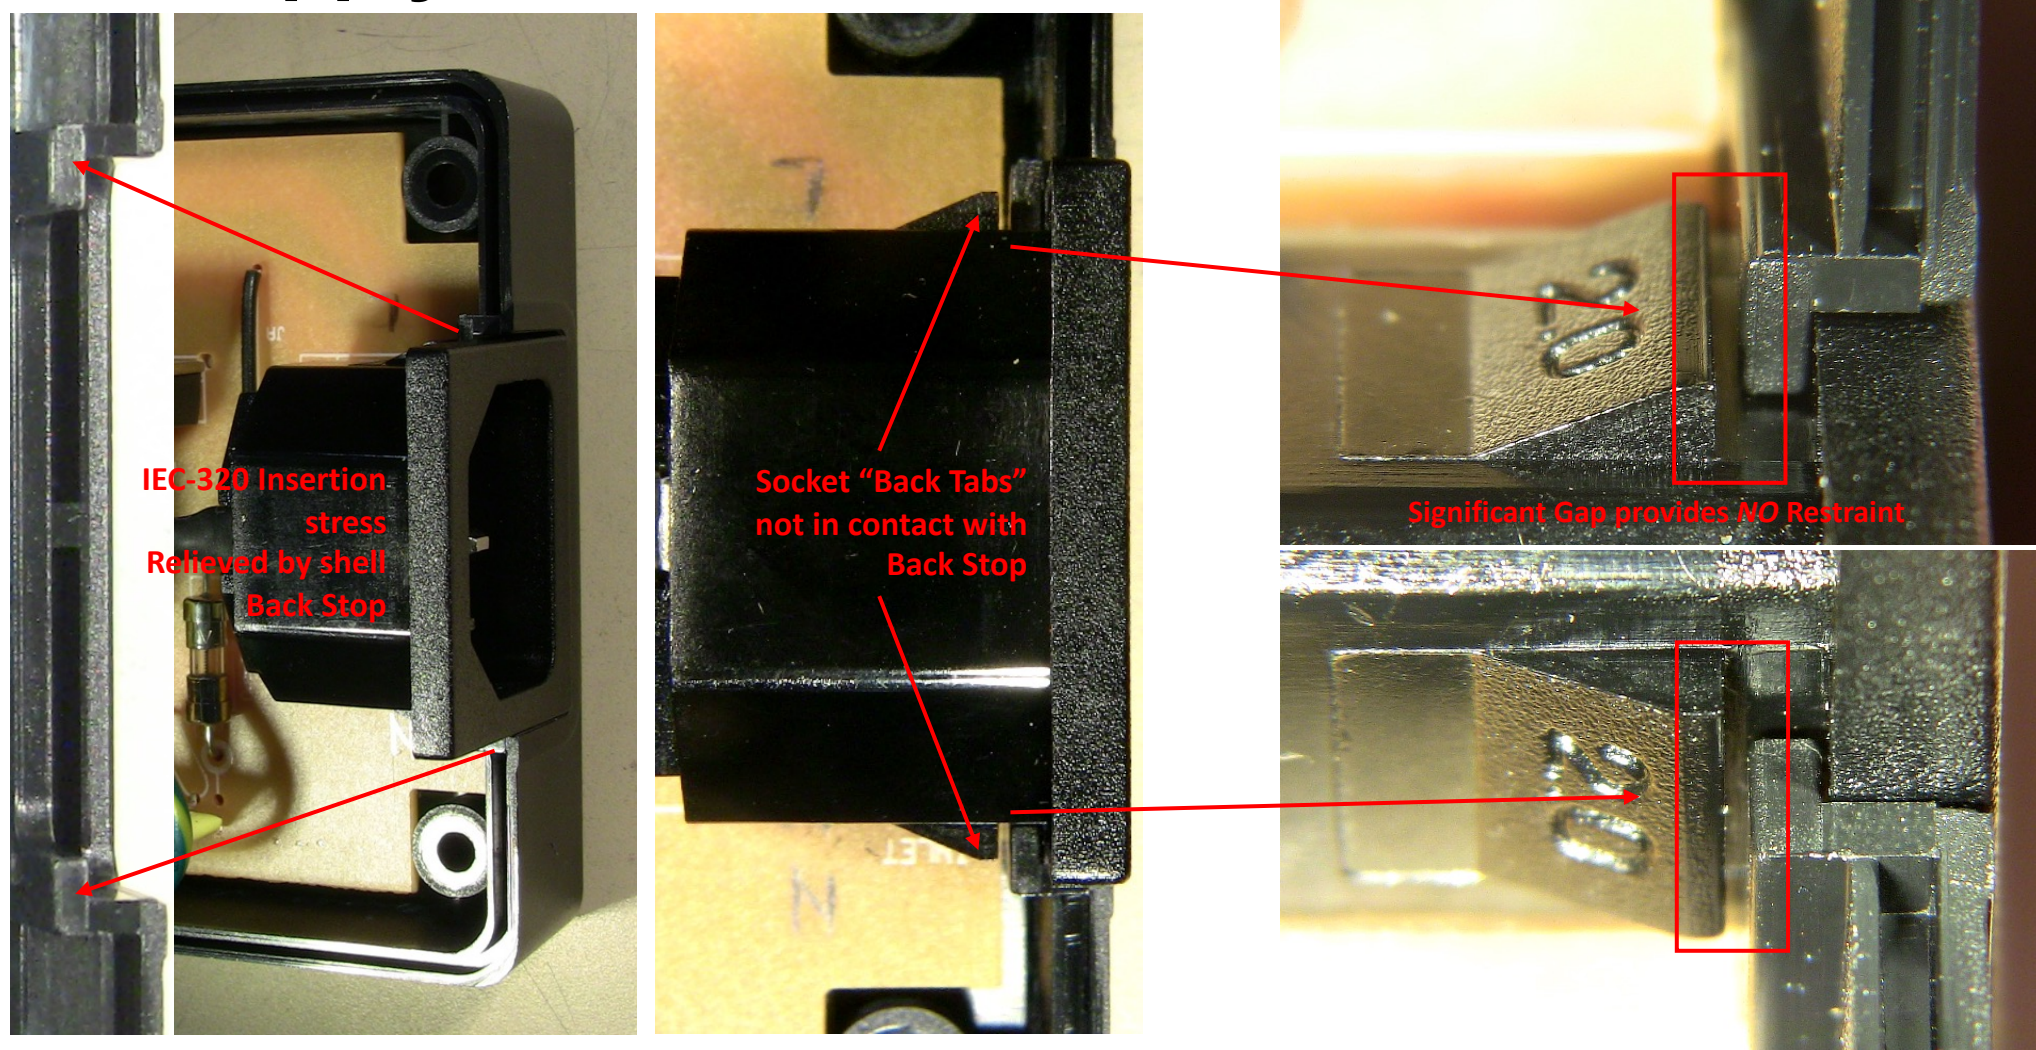
Power Supply- Board & Socket fit in relation to outer enclosure

Mis-application **ALLOWS** mechanical stress transfer to AC Line solder joints. No board Staking OR retention features

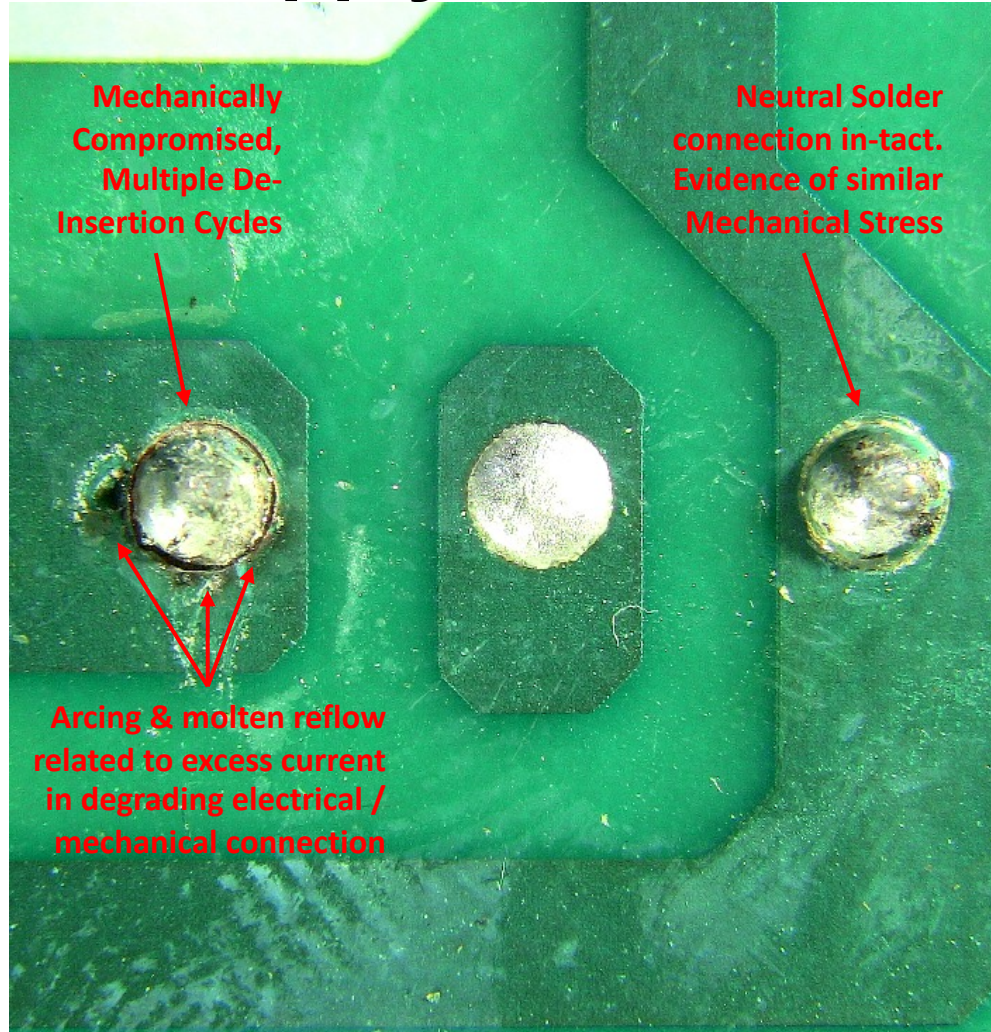
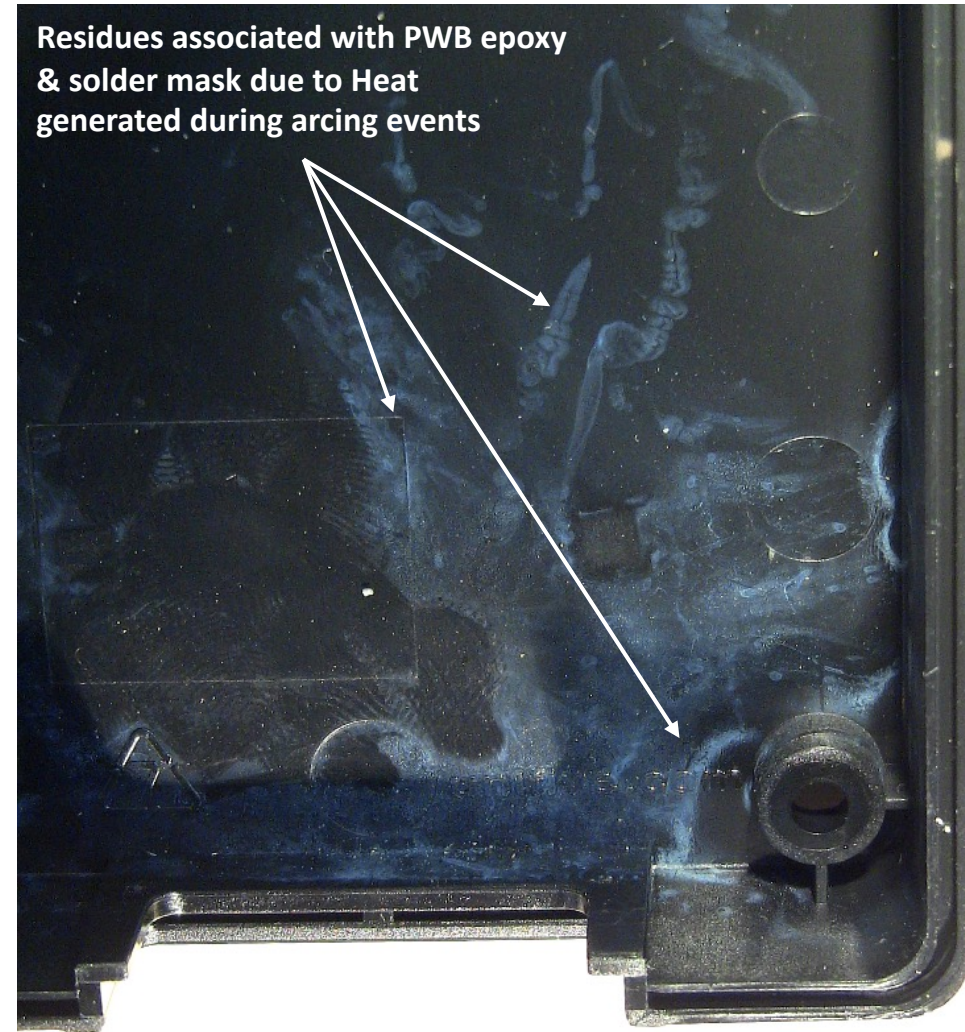
Solder connection- Mechanical / thermal degradation due to cyclical use, residues are from interconnect arcing

It was confirmed with offset lighting that the AC Line in solder joint was badly damaged. The board was charred around the un plated thru-hole. Copper separation and solder melted away from the AC line pin a full 360 degrees.

2. AC Neutral In solder was probed to the inputs, electrical continuity to this and the ground pin were confirmed.
3. Mechanical / Electrical Breakdown- Copper damage with multiple arc locations indicate that the connection suffered from end use cyclical power cord insertion / removal fatigue stress, leading to a compromised electrical connection. This increased current density, resulting in excess heat and solder reflow. This led to connection degradation and eventual failure.

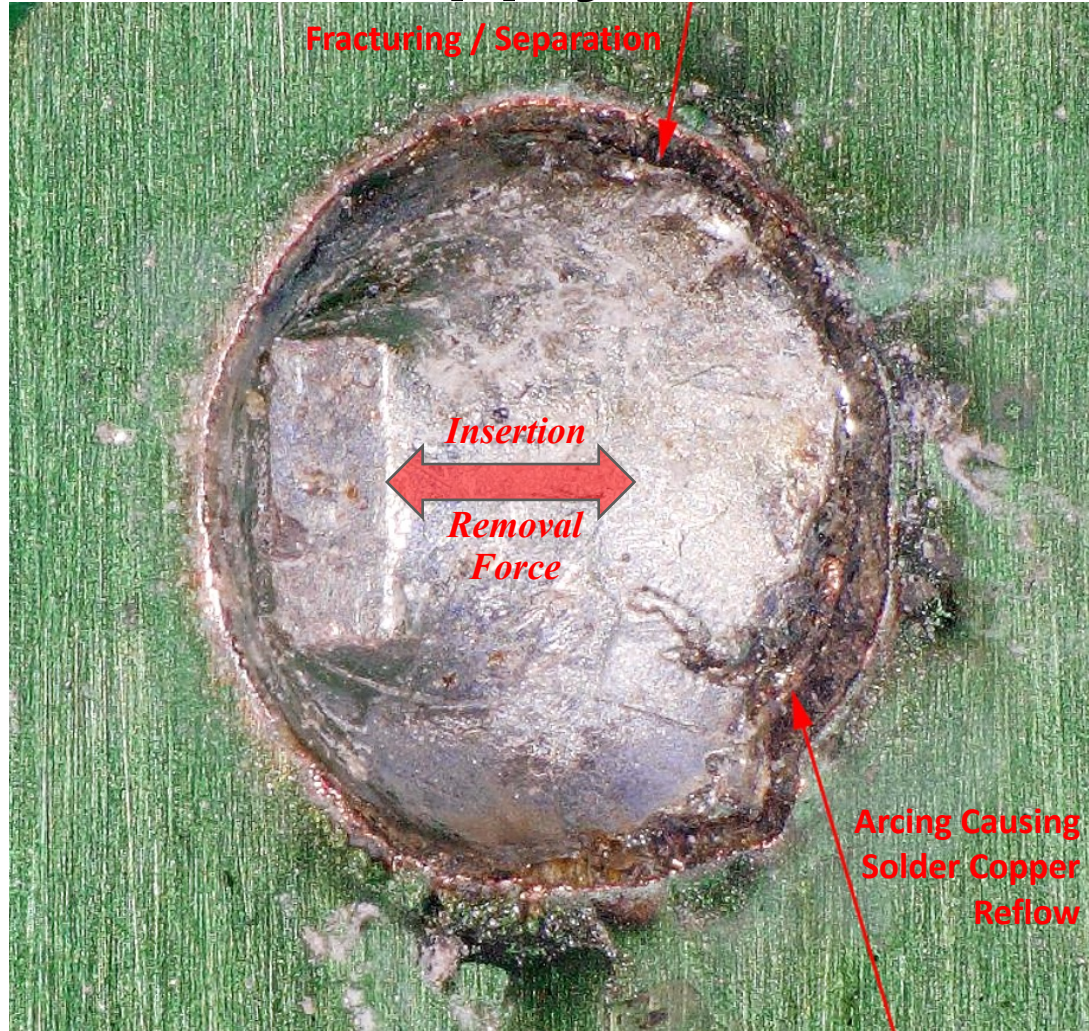
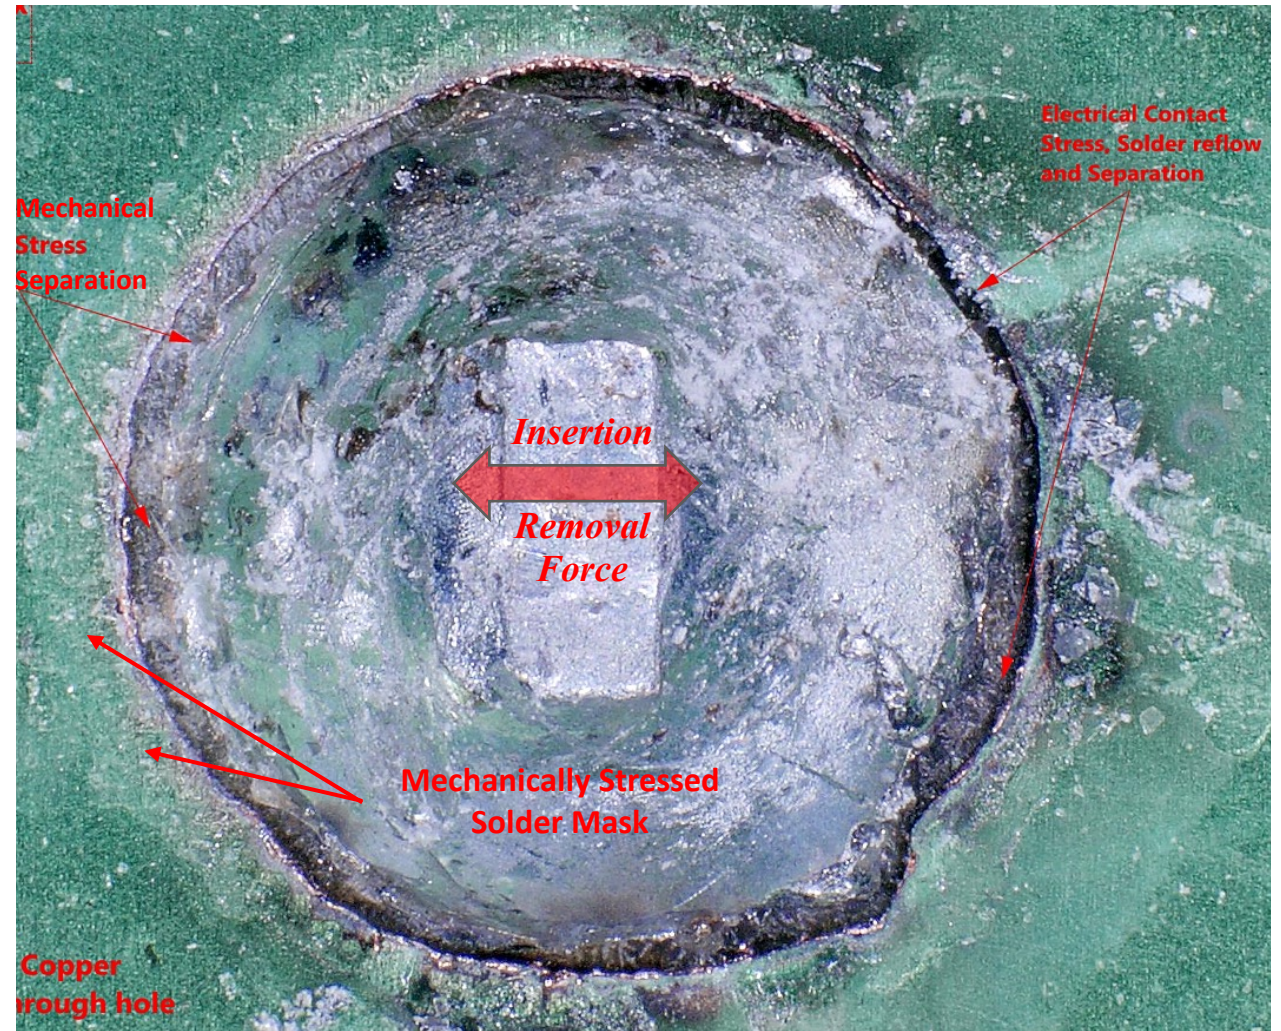
Solder connection- Mechanical / thermal degradation due to cyclical use, residues are from interconnect arcing

11. Mechanical damage on one side of the solder joint, with Arcing leading to an eventual open on the other side is consistent with the orientation and direction to which the AC power cord is inserted, then pulled out.

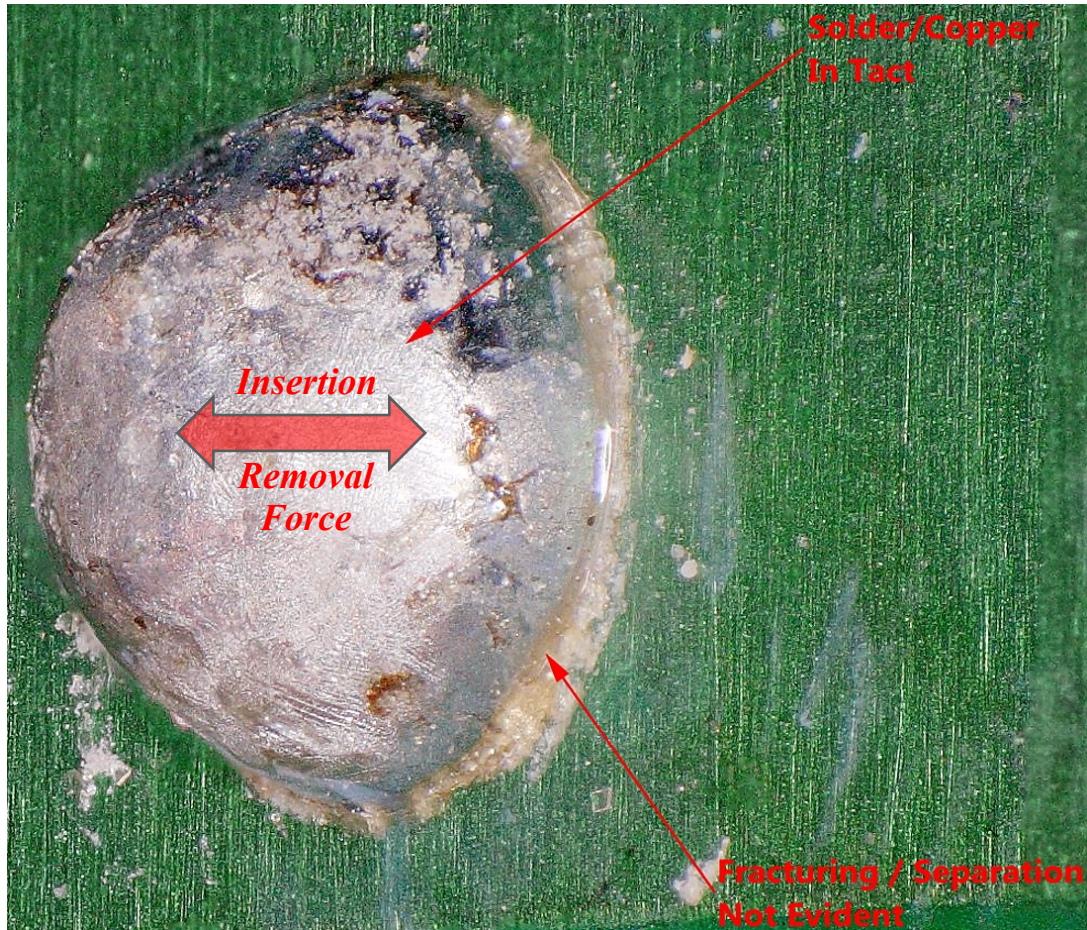
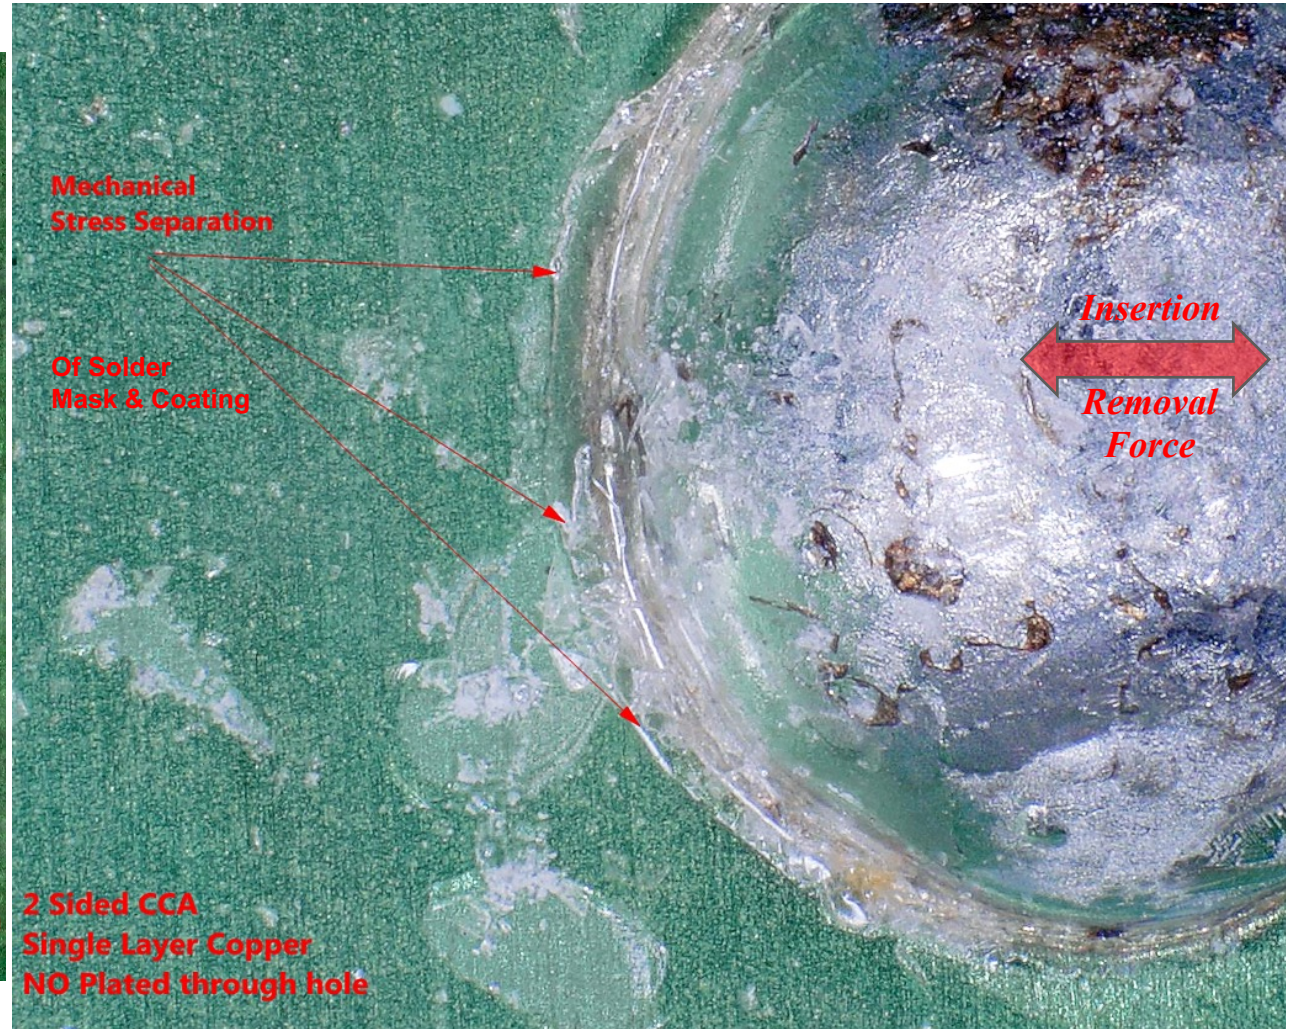
Solder connection is in-Tact, though not ideal. Electrical connection is not compromised

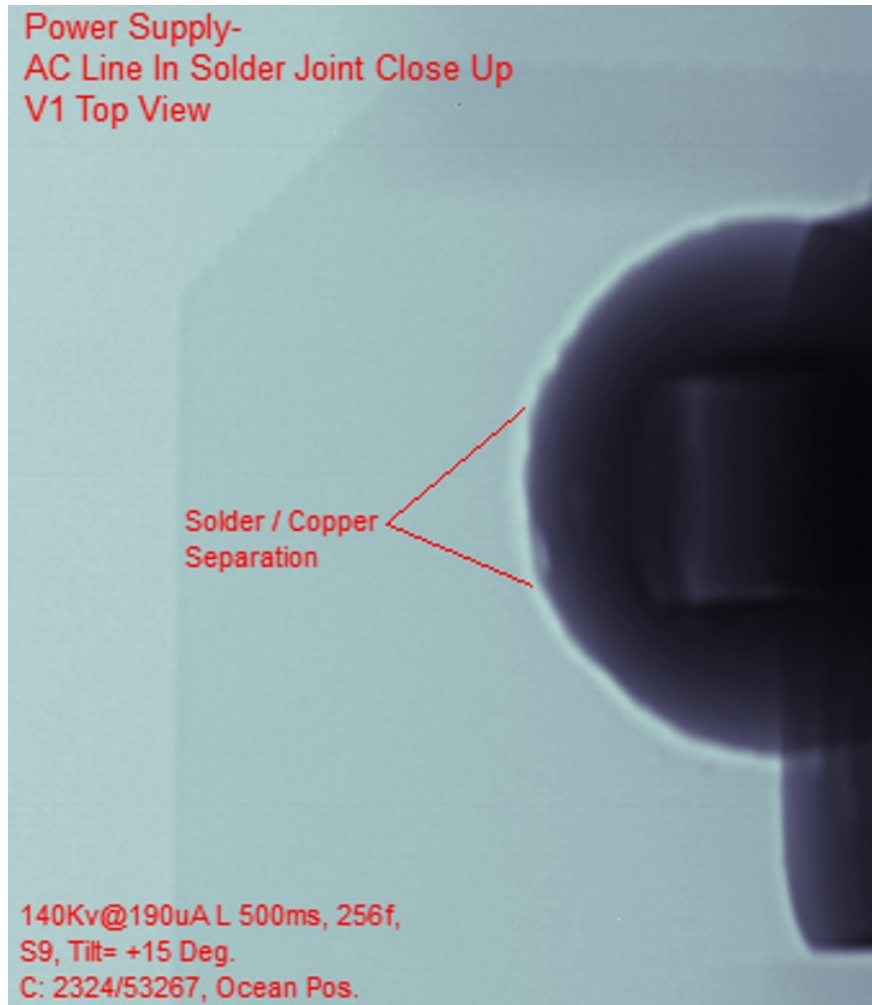
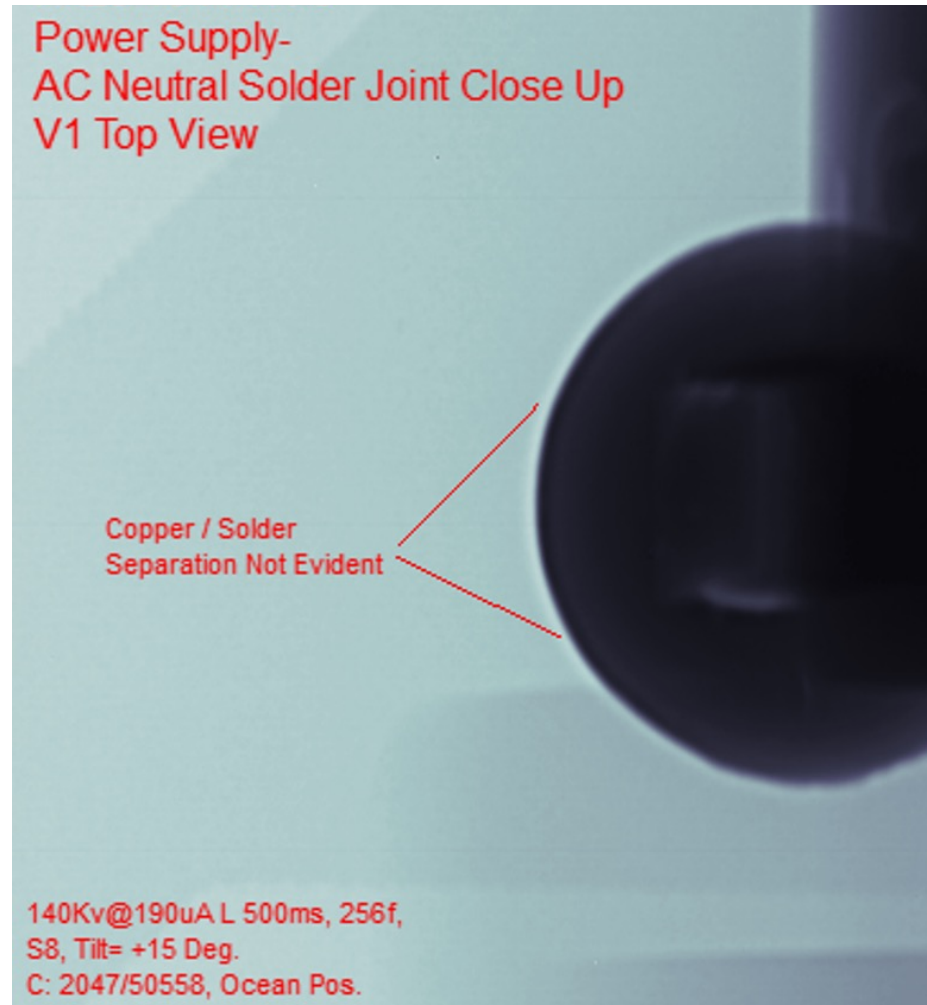
IEC-320 main board solder attach- X-Ray confirms compromised AC Line In solder joint

4. X-rays of the solder connections and the fuses confirmed the findings in Items 1-3 above.
5. The enclosure assembly bottom, contains multiple smoke emission trails from where the AC Line In solder connection is. This is a result of multiple instances of arcing, which burned the board material, solder mask and coatings, depositing localized residues.

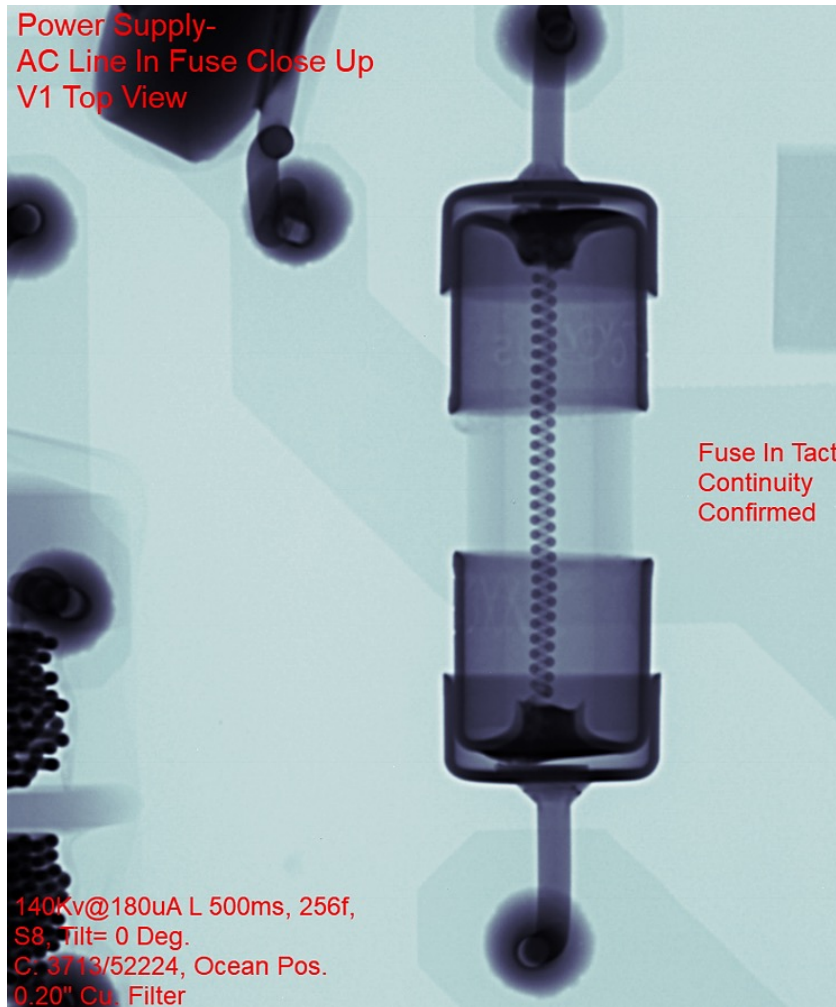
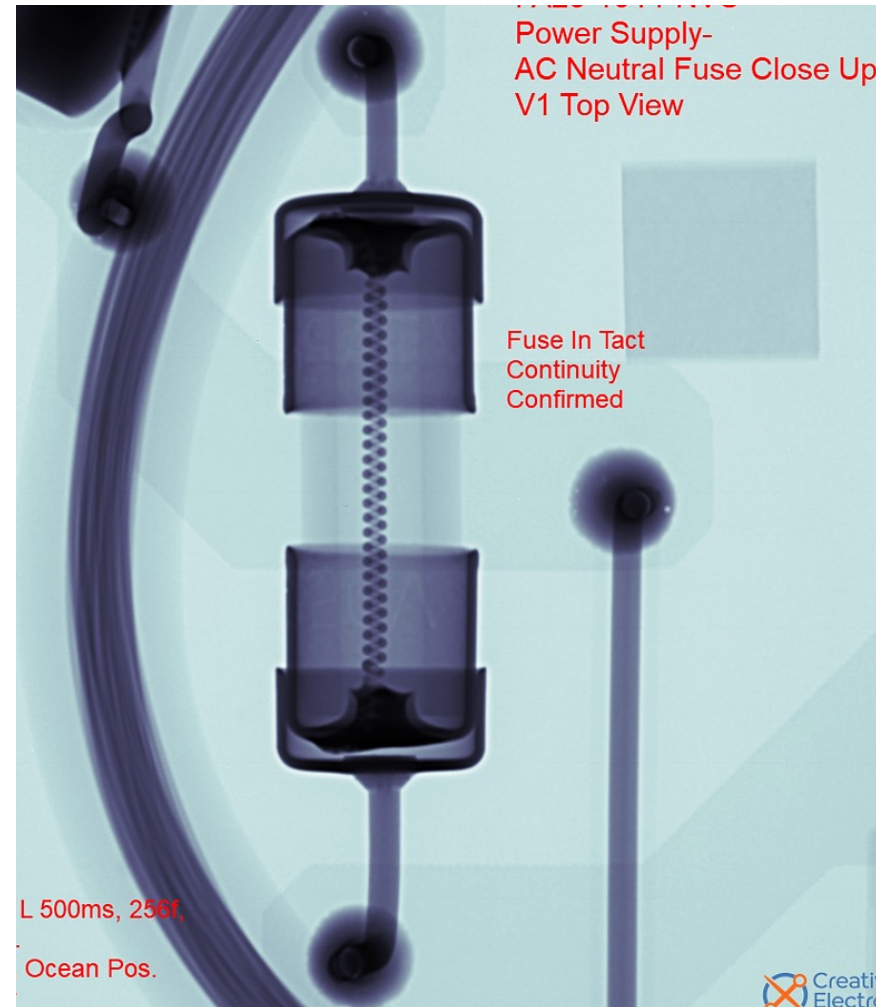
AC Line & Neutral Fuses. Elements have electrical continuity and are *in-tact*

1. Input connections were probed with a multi-meter confirming an electrical open from the solder joint to power in. Line AC In & Neutral fuses were also tested and confirmed to be in-tact.
