ESS Vibration Failure of a COTS Power Supply

Aaron C. Dermarderosian
Senior Principal General Engineer
Misson Systems Services

May 1st, 2024

Failure Investigation- COTS AC/DC Converter; 5 & 12V DC Output

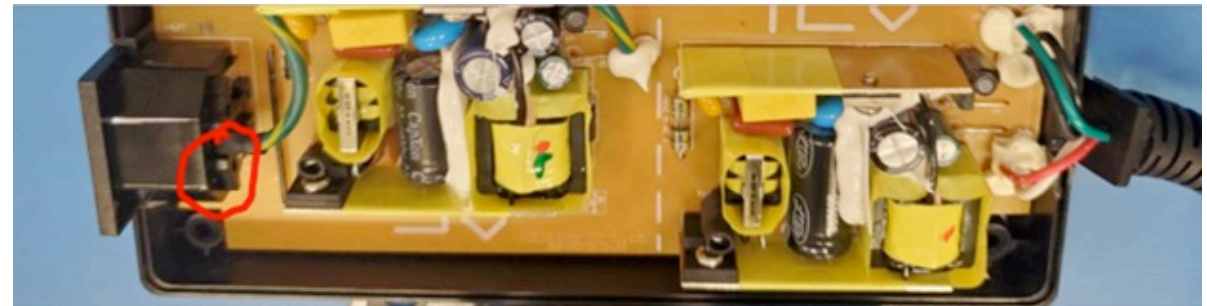
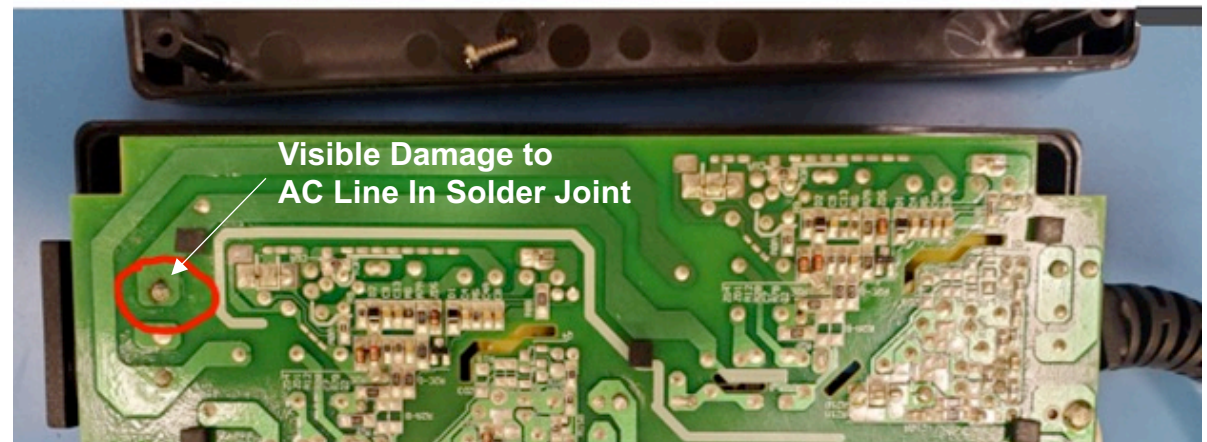
A switchable (120/240V) portable AC/DC power supply failed following transit case vibration qualification tests.

1. Portable supply functionally tested before and after testing.
2. No power output from 5VDC or 12VDC outputs, following qualification test.
3. Initial dis-assembly showed there was a failed solder joint on the AC Line connection to the PCB.

Request- Determine if failure was related to vibration testing
